**Flood Control Project Maintenance
Levee Inspections**
LMA District Cover Sheet
Spring 2019 Levee Inspection Results

American River Flood Control District

Spring 2019 Levee Inspection Results

Waterway			Bank	Unit Miles
Unit No. 01 Arcade Creek			Left	2.08
	Spring (March - May)	Summer (June - August)	(September - November) Fall	Winter (December - February)
Unit Maintenance Rating (Fall Only)				
Date of Inspection	5/14/2019 - 5/14/2019			
DWR Inspector	Luz Dial			
Accompanied By	Ross Kawamura ARFCD

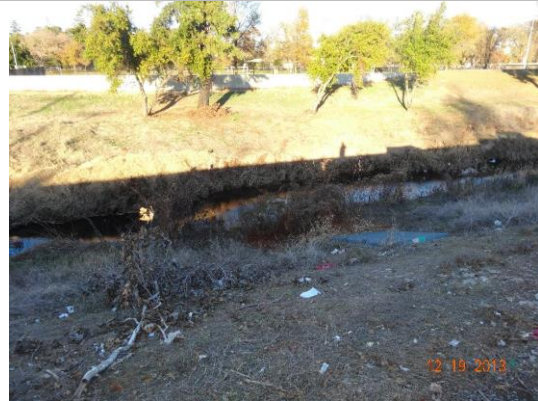
Photo 3 of 3 : UCIP_SP_2019_41549_57085.jpg

Debris screen visible on waterward slope.

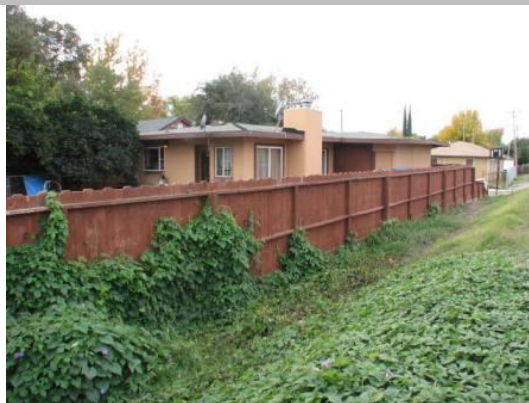
Photo 1 of 1 : SP_2019_NA0001_51_167_20190307_00052.jpg

LM Start	1.98	Rating **	U	Issue No.	167
LM End	1.98	Issue Type +	En	Location *	LS
Category	Earthen Levee			GPS Latitude/Longitude	
				Start	End
Item	Encroachments			38.627433 °	38.627433 °
				-121.434341 °	-121.434341 °
DWR ID	DWR_NA0001_01_s_2012_167				
Comment Code					
FE : Fence					
Inspector Comment					
Wooden privacy fence within 10' of the levee toe.

11/17/2011 Wooden privacy fence built at the levee toe.

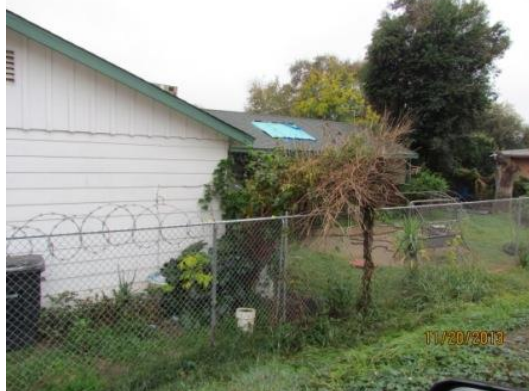
Photo 1 of 1 : SP_2019_NA0001_51_1_20190307_00001.jpg

LM Start	1.99	Rating **	M	Issue No.	1
LM End	1.99	Issue Type +	En	Location *	LS
Category	Earthen Levee			GPS Latitude/Longitude	
				Start	End
Item	Vegetation			38.627318 °	38.627318 °
				-121.434208 °	-121.434208 °
DWR ID	DWR_NA0001_01_s_2012_1				
Comment Code					
V6 : Landscaping					
Inspector Comment					
Vine growing on fence and slope blocks visibility.

View of the fence and landscaping at the landside levee toe.

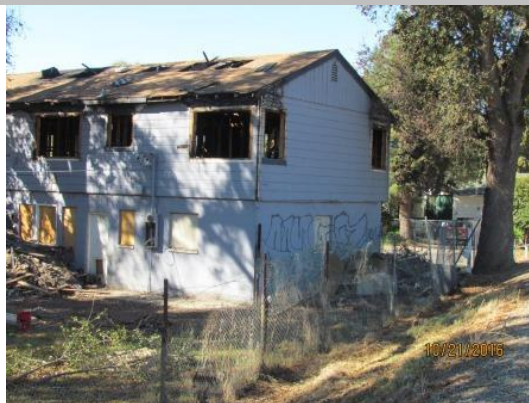
Photo 1 of 1 : SP_2019_NA0001_51_29_20190307_00023.jpg

LM Start	2.02	Rating **	U	Issue No.	29
LM End	2.02	Issue Type +	En	Location *	LS
Category	Earthen Levee			GPS Latitude/Longitude	
				Start	End
Item	Encroachments			38.627292 °	38.627292 °
				-121.433709 °	-121.433709 °
DWR ID	DWR_NA0001_01_s_2012_29				
Comment Code					
BU : Building					
Inspector Comment					
Two-story home foundation is within 10-ft of levee toe. Chain link fence is built on levee toe.

Building foundation is within 15' of the levee toe.

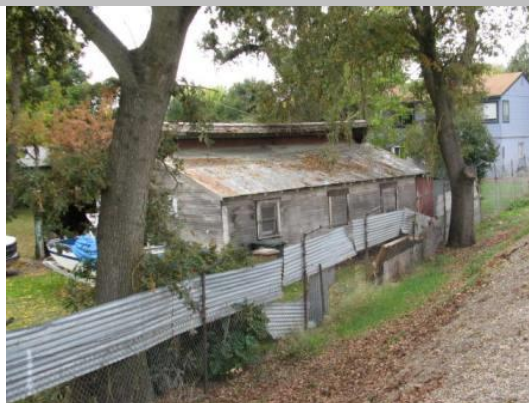
Photo 1 of 1 : SP_2019_NA0001_51_28_20190307_00022.jpg

LM Start	2.04	Rating **	U	Issue No.	28
LM End	2.04	Issue Type +	En	Location *	LS
Category	Earthen Levee			GPS Latitude/Longitude	
				Start	End
Item	Encroachments			38.627257 °	38.627257 °
				-121.433327 °	-121.433327 °
DWR ID	DWR_NA0001_01_s_2012_28				
Comment Code					
BU : Building					
Inspector Comment					
Large wooden building behind corrugated metal covered fence is within 10-ft of levee toe.

11/17/2011 Wooden structure is within 15' of the levee toe.

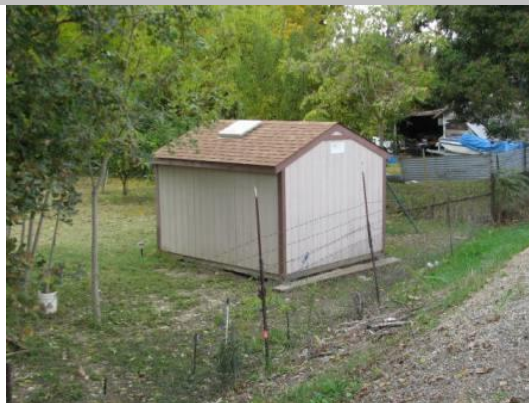
Photo 1 of 1 : SP_2019_NA0001_51_27_20190307_00021.jpg

LM Start	2.05	Rating **	M	Issue No.	27
LM End	2.05	Issue Type +	En	Location *	LS
Category	Earthen Levee			GPS Latitude/Longitude	
				Start	End
Item	Encroachments			38.627230 °	38.627230 °
				-121.433039 °	-121.433039 °
DWR ID	DWR_NA0001_01_s_2012_27				
Comment Code					
BU : Building					
Inspector Comment					
Pre-fab storage shed is within 10-ft of landside toe.

11/17/2011 Wooden structure is within 15' of the levee toe.

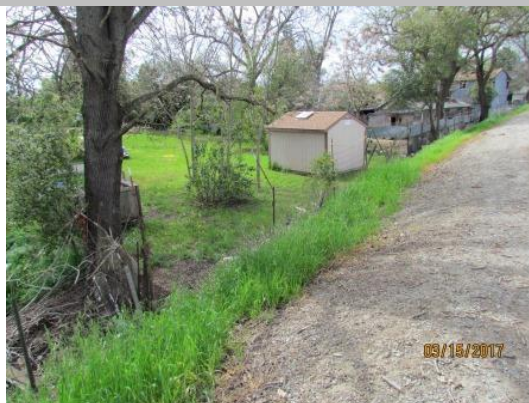
Photo 1 of 1 : SP_2019_NA0001_51_52_20190307_00034.jpg

LM Start	2.05	Rating **	M	Issue No.	52
LM End	2.05	Issue Type +	En	Location *	LS
Category	Earthen Levee			GPS Latitude/Longitude	
				Start	End
Item	Encroachments			38.627254 °	38.627254 °
				-121.433026 °	-121.433026 °
DWR ID	DWR_NA0001_01_f_2015_52				
Comment Code					
FE : Fence					
Inspector Comment					
Fence at the landside levee toe.

View of the fence at the levee toe.

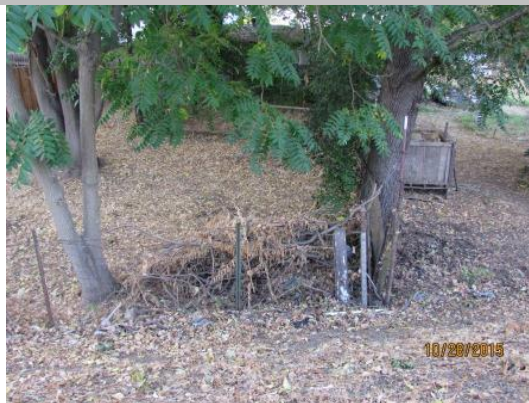
Photo 1 of 1 : SP_2019_NA0001_51_47_20190307_00030.jpg

LM Start	2.06	Rating **	M	Issue No.	47
LM End	2.06	Issue Type +	En	Location *	LS
Category	Earthen Levee			GPS Latitude/Longitude	
				Start	End
Item	Encroachments			38.627255 °	38.627255 °
				-121.432876 °	-121.432876 °
DWR ID	DWR_NA0001_01_f_2015_47				
Comment Code					
PR : Prunings					
Inspector Comment

View of the prunings at the landside levee toe.

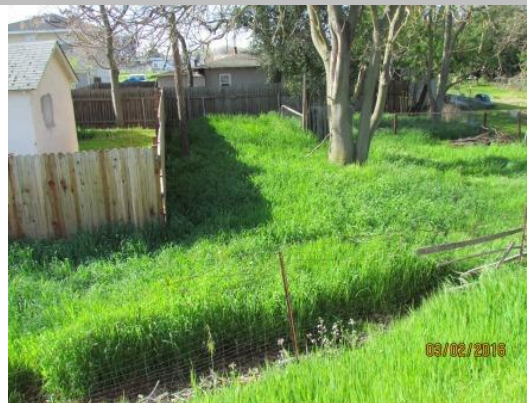
Photo 1 of 1 : SP_2019_NA0001_51_51_20190307_00033.jpg

LM Start	2.06	Rating **	M	Issue No.	51
LM End	2.06	Issue Type +	En	Location *	LS
Category	Earthen Levee			GPS Latitude/Longitude	
				Start	End
Item	Encroachments			38.627251 °	38.627251 °
				-121.432843 °	-121.432843 °
DWR ID	DWR_NA0001_01_f_2015_51				
Comment Code					
FE : Fence					
Inspector Comment					
Fence at landside levee toe.

View of the fence at the landside levee toe.

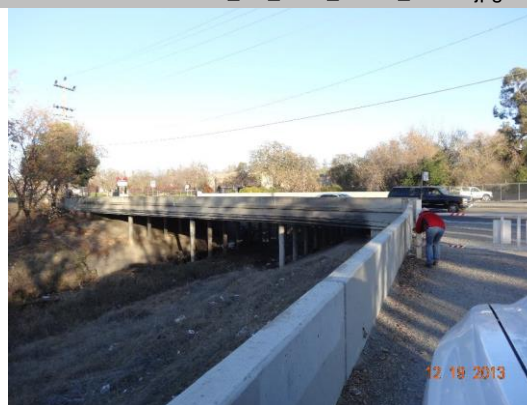
Photo 1 of 3 : UCIP_SP_2019_31185_57091.jpg

LM Start	2.08	Rating **	M	Issue No.	193
LM End	2.08	Issue Type +	En	Location *	
Category	Supplemental			GPS Latitude/Longitude	
				Start	End
Item	DWR UCIP Field Study			38.627239 °	38.627239 °
				-121.432501 °	-121.432501 °
DWR ID	24420				
Comment Code					
Inspector Comment					
FS_ID:31185 DS_ID:24420 EP_NO: 13044 Repair Type: Non-Urgent Crossing Status: Indicator Found UCIP Comments: Orange/Green symbol for flood structure found on floodwall. No crossing found. Need to determine if crossing is in use. This crossing is not shown in the City of Sacramento's sewer drain mains or water mains. Need to contact owner to determine if crossing is still in use. FIELD_STRUCT_DESC: 12-inch steel water main through the levee, 4 feet below the crown. (12-inch pipe authorized under Permit No. 13044, 1981-City of Sacramento) FS Date: 12/19/2013

Overview markers located on bridge and floodwall indicating crossing through levee.

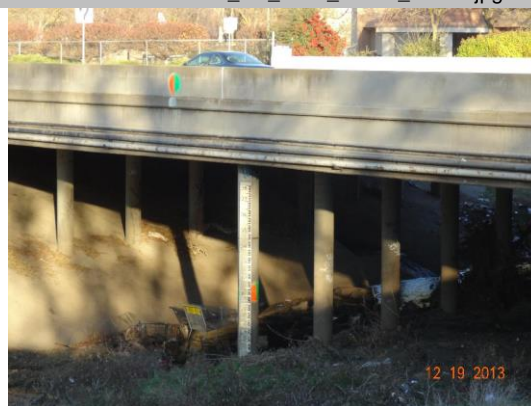
Photo 2 of 3 : UCIP_SP_2019_31185_57090.jpg

LM Start	2.08	Rating **	M	Issue No.	193 (cont)	
LM End	2.08	Issue Type +	En	Location *		
Category	Supplemental			GPS Latitude/Longitude		
				Start		End
Item	DWR UCIP Field Study			38.627239 °		38.627239 °
				-121.432501 °		-121.432501 °
DWR ID	24420					
Comment Code						
Inspector Comment						
FS_ID:31185 DS_ID:24420 EP_NO: 13044 Repair Type: Non-Urgent Crossing Status: Indicator Found UCIP Comments: Orange/Green symbol for flood structure found on floodwall. No crossing found. Need to determine if crossing is in use. This crossing is not shown in the City of Sacramento's sewer drain mains or water mains. Need to contact owner to determine if crossing is still in use. FIELD_STRUCT_DESC: 12-inch steel water main through the levee, 4 feet below the crown. (12-inch pipe authorized under Permit No. 13044, 1981-City of Sacramento) FS Date: 12/19/2013

Markers visible of crossing on bridge.

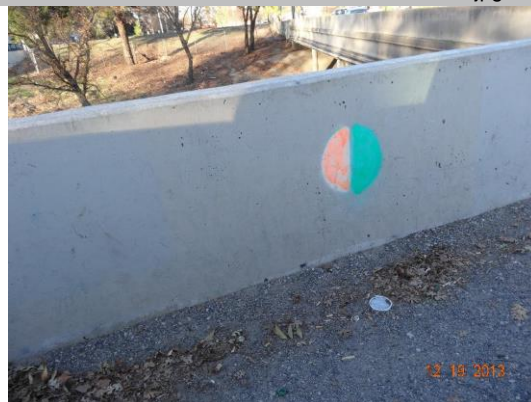
Photo 3 of 3 : UCIP_SP_2019_31185_57089.jpg

Marker of crossing on floodwall indicating crossing through levee.

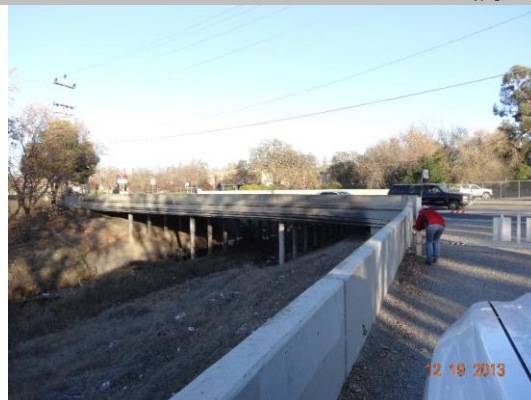
Photo 1 of 2 : UCIP_SP_2019_31424_57481.jpg

LM Start	2.08	Rating **	M	Issue No.	194
LM End	2.08	Issue Type +	En	Location *	
Category	Supplemental			GPS Latitude/Longitude	
				Start	End
Item	DWR UCIP Field Study			38.627242 °	38.627242 °
				-121.432469 °	-121.432469 °
DWR ID	24797				
Comment Code					
Inspector Comment					
FS_ID:31424					
DS_ID:24797					
EP_NO: N/A					
Repair Type: Non-Urgent					
Crossing Status: Found					
UCIP Comments: no permit--need to determine additional information and owner of crossings.					
FIELD_STRUCT_DESC: one 4-inch conduit and one 2-inch communication cable through levee at an unknown depth below the crown. Conduits are suspended through waterway and attached to downstream face of bridge.					
FS Date: 12/19/2013

View of waterward side--conduits visible on bridge face.

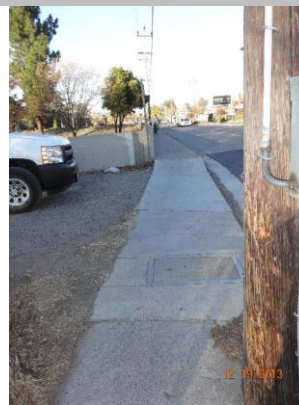
Photo 2 of 2 : UCIP_SP_2019_31424_57480.jpg

Service box located on sidewalk unable to determine if box belongs to conduits.

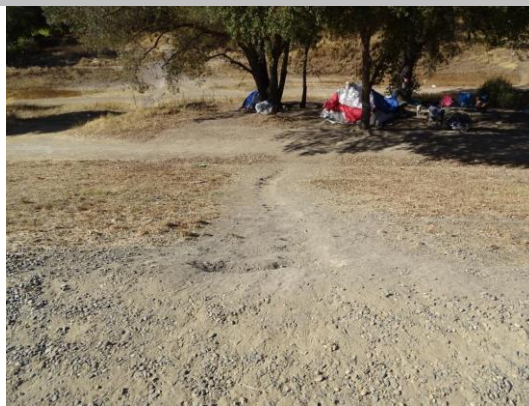
Photo 1 of 1 : SP_2019_NA0001_52_39_20190307_00021.jpg

LM Start	0.17	Rating **	A/W	Issue No.	39
LM End	0.17	Issue Type +	Ma	Location *	WS
Category	Earthen Levee			GPS Latitude/Longitude	
				Start	End
Item	Slope Stability			38.604455 °	38.604455 °
				-121.470417 °	-121.470417 °
DWR ID	DWR_NA0001_02_f_2018_39				
Comment Code					
S2 : Repair the levee slope damaged by foot traffic and prevent access where possible.					
Inspector Comment					
Monitor footpath on waterside slope.

View of stair steps dug into levee slope. Fall 2018

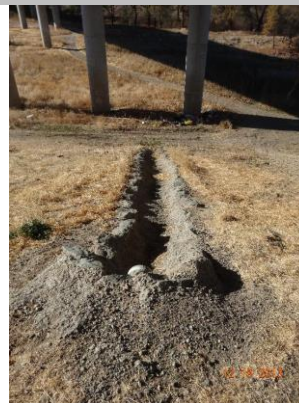
Photo 1 of 3 : UCIP_SP_2019_31443_57484.jpg

Comment Code						
Inspector Comment						
FS_ID:31443 DS_ID:24798 EP_NO: N/A Repair Type: Non-Urgent Crossing Status: Indicator Found UCIP Comments: 08/16/2017 DWR Deferred Maintenance Project (DMP), Vince Rodriguez, forwarded email received from Tim Kerr, General Manager of American River Flood Control District (ARFCD) with file "DWR Eligible Pipes Found in ARFCD" from ARFCD that shows the ownership and location of the pipes Tim Kerr investigated. No owner was identified, ARFCD Staff Notes indicate 4-inch HDPE under Arden-Garden Connector. (DWR UCIP - O. Magana) 12/06/2013 no permit (unauthorize crossing)--need to determine additional information about crossing. Unable to determine if pipe crosses levee. (DWR UCIP - O. Magana) FIELD_STRUCT_DESC: 4-inch high density polyethylene (HDPE) pipe through levee at unknown depth. (no permit has been identified authorizing this crossing, owner has not been identified) FS Date: 12/6/2013

View of waterward slope.

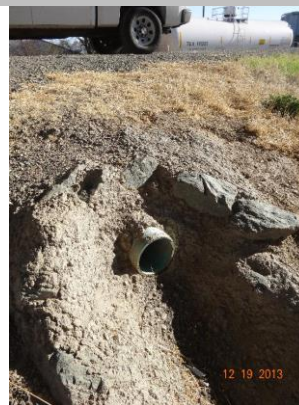
Photo 2 of 3 : UCIP_SP_2019_31443_57483.jpg

View of pipe through levee.

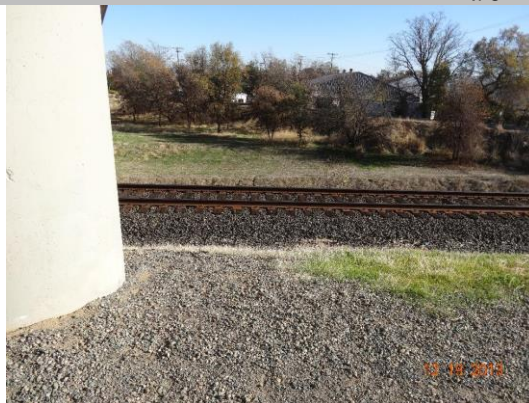
Photo 3 of 3 : UCIP_SP_2019_31443_57482.jpg

Comment Code						
Inspector Comment						
FS_ID:31443 DS_ID:24798 EP_NO: N/A Repair Type: Non-Urgent Crossing Status: Indicator Found UCIP Comments: 08/16/2017 DWR Deferred Maintenance Project (DMP), Vince Rodriguez, forwarded email received from Tim Kerr, General Manager of American River Flood Control District (ARFCD) with file "DWR Eligible Pipes Found in ARFCD" from ARFCD that shows the ownership and location of the pipes Tim Kerr investigated. No owner was identified, ARFCD Staff Notes indicate 4-inch HDPE under Arden-Garden Connector. (DWR UCIP - O. Magana) 12/06/2013 no permit (unauthorize crossing)--need to determine additional information about crossing. Unable to determine if pipe crosses levee. (DWR UCIP - O. Magana) FIELD_STRUCT_DESC: 4-inch high density polyethylene (HDPE) pipe through levee at unknown depth. (no permit has been identified authorizing this crossing, owner has not been identified) FS Date: 12/6/2013

View of landward side.

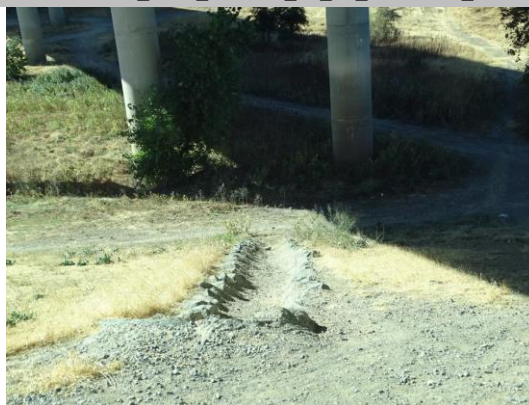
Photo 1 of 1 : SP_2019_NA0001_52_42_20190307_00024.jpg

LM Start	0.36	Rating **	A/W	Issue No.	42
LM End	0.36	Issue Type +	Ma	Location *	WS
Category	Earthen Levee			GPS Latitude/Longitude	
				Start	End
Item	Slope Stability			38.606229 °	38.606229 °
				-121.467867 °	-121.467867 °
DWR ID	DWR_NA0001_02_f_2018_42				
Comment Code					
S2 : Repair the levee slope damaged by foot traffic and prevent access where possible.					
Inspector Comment					
Repair slope damage from a footpath dug into the slope. Part of overpass drainage.

View of footpath dug into levee slope and lined with rocks. Fall 2018

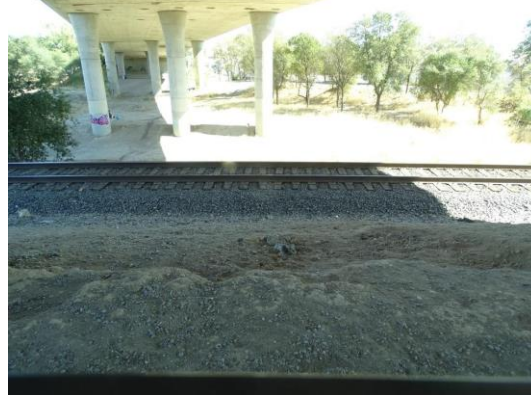
Photo 1 of 1 : SP_2019_NA0001_52_21_20190307_00008.jpg

LM Start	0.37	Rating **	M	Issue No.	21
LM End	0.37	Issue Type +	Ma	Location *	LS
Category	Earthen Levee			GPS Latitude/Longitude	
				Start	End
Item	Slope Stability			38.606430 °	38.606430 °
				-121.467782 °	-121.467782 °
DWR ID	DWR_NA0001_02_f_2018_21				
Comment Code					
S1 : Repair slope instability.					
Inspector Comment					
Repair slope damage.

View of slope damage on levee slope. Fall 2018

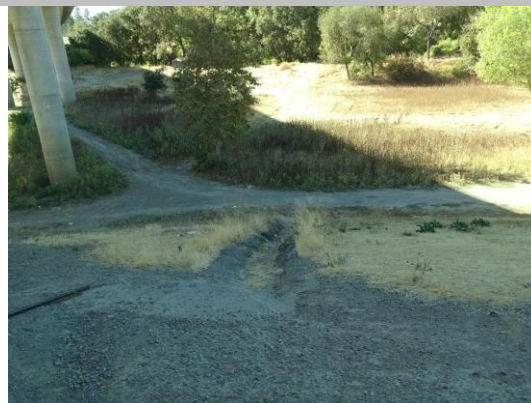
Photo 1 of 1 : SP_2019_NA0001_52_43_20190307_00025.jpg

LM Start	0.37	Rating **	A/W	Issue No.	43
LM End	0.37	Issue Type +	Ma	Location *	WS
Category	Earthen Levee			GPS Latitude/Longitude	
				Start	End
Item	Slope Stability			38.606435 °	38.606435 °
				-121.467772 °	-121.467772 °
DWR ID	DWR_NA0001_02_f_2018_43				
Comment Code					
S2 : Repair the levee slope damaged by foot traffic and prevent access where possible.					
Inspector Comment					
Repair slope damage from footpath dug into slope. Part of overpass drainage.

View of footpath dug into levee slope and lined with rocks. Fall 2018

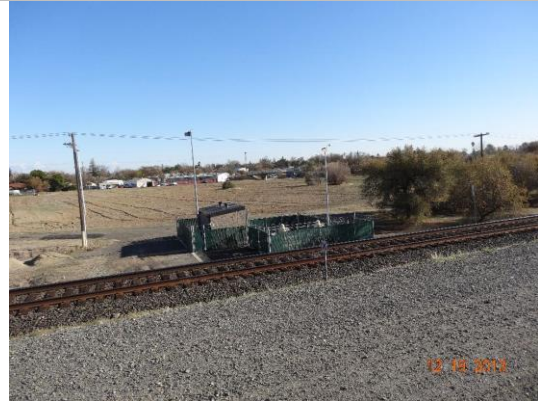
Photo 1 of 3 : UCIP_SP_2019_49533_55042.jpg

Comment Code					
Inspector Comment					
FS_ID:49533 DS_ID:24274 EP_NO: 6064 Repair Type: Non-Urgent Crossing Status: Found UCIP Comments: 08/29/2016 Facility details confirmed by the City of Sacramento only one 36-inch WSP goes through levee at this location. Ownership in the CVFPB records still shows ARFCD. Efforts to update CVFPB records are in-progress, owner of this facility is the City of Sacramento. Need to coordinate with ARFCD and City of Sacramento to determine the fate of Pump Station 3. (DWR UCIP - Olivia M)12/19/2013 Need to determine the status of crossing. Unable to confirm if crossing found in field corresponds to this entry. FIELD_STRUCT_DESC: [Sump No. 153] 36-inch welded steel drainage pipe (WSP) with 15/32-inch wall thickness through the levee, 5.2 feet below the crown. Corrugated metal (CM) cutoff wall around pipe between center and waterside (WS) shoulder. Siphon breaker in concrete box on WS slope. 36-inch pipe connects, past LS toe, through header 2-30 inch WSP and 1-12 inch WSP at this facility. Pump station located on landside (LS). Concrete "U" headwall and flap gate are located on the WS end. Rock revetment on WS slope. On March 28, 1995, the Sacramento City Council adopted Resolution No. 95-123 authorizing the execution of Agreement No. 95-065 regarding the transfer of drainage facilities that include Pump Station 3 as described by ARFCD and described by the City of Sacramento as Sump 153. Pump Station 3 was replaced by Sump 3. (36-inch pipe installed under Permit No. 6064 and 6064-A, 1968 - American River Flood Control District [ARFCD]) [Additional Reference (s): DWR Levee Log, 2002, City of Sacramento D 151-159_CC1995-95-062_Transfer of Drainage Sumps to City from ARFCD, and City of Sacramento Sump 153 Plan and Profile] FS Date: 12/19/2013

View of landward side--pump station with multiple pumps.

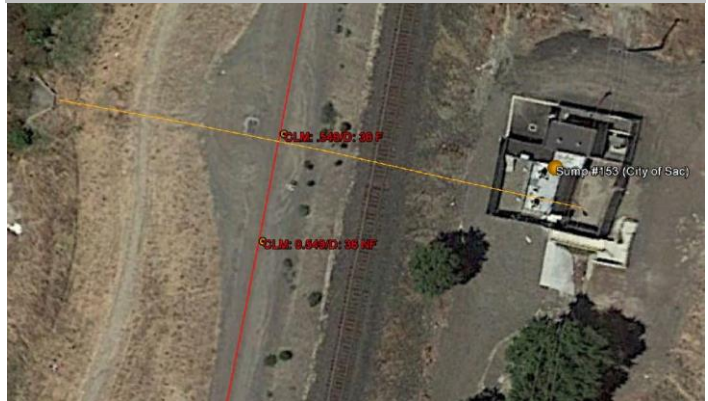
Photo 1 of 2 : UCIP_SP_2019_51428_75580.jpg

FS_ID:51428
DS_ID:24612
EP_NO: N/A
Repair Type: Non-Urgent
Crossing Status: Not Found
UCIP Comments: 08/29/2016 Facility details confirmed by the City of Sacramento. This crossing was an existing pipe that was mentioned in Permit No. 6064 and 6064-A under the following conditions: Thirteen: "that the existing 36-inch diameter corrugated metal pipe shall be allowed to remain in place for a period of 10 years, (until May 1978), at which time if the old pumping plant has not been used the pipe through the levee shall be removed by the applicant." and Fifteen: "That the existing 36-inch pipe shall be properly capped or sealed on both ends. Need to coordinate with the City of Sacramento and ARFCD to determine the fate of this crossing. Application No. 6064 references U.S. Corps of Engineers Stat. 217+00 as Pump Plant No. 3. (DWR UCIP - O. Magana)12/19/2013 Multiple pumps visible on landward side however unable to confirm additional crossings. Only 1 crossing was found at this location. (DWR UCIP - O. Magana)

Approx. location of USACE O&M original 36-inch located 40 feet downstream from Sump 153.

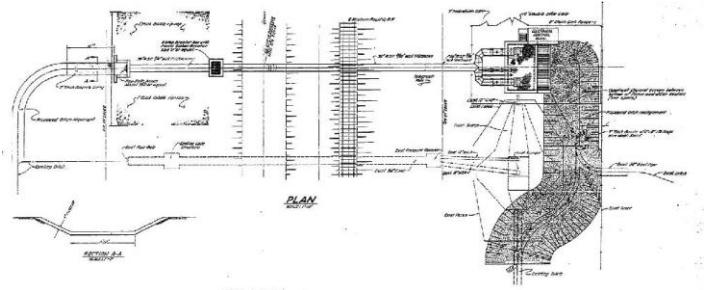
Photo 2 of 2 : UCIP_SP_2019_51428_75578.jpg

FS_ID:51428
DS_ID:24612
EP_NO: N/A
Repair Type: Non-Urgent
Crossing Status: Not Found
UCIP Comments: 08/29/2016 Facility details confirmed by the City of Sacramento. This crossing was an existing pipe that was mentioned in Permit No. 6064 and 6064-A under the following conditions: Thirteen: "that the existing 36-inch diameter corrugated metal pipe shall be allowed to remain in place for a period of 10 years, (until May 1978), at which time if the old pumping plant has not been used the pipe through the levee shall be removed by the applicant." and Fifteen: "That the existing 36-inch pipe shall be properly capped or sealed on both ends. Need to coordinate with the City of Sacramento and ARFCD to determine the fate of this crossing. Application No. 6064 references U.S. Corps of Engineers Stat. 217+00 as Pump Plant No. 3. (DWR UCIP - O. Magana)12/19/2013 Multiple pumps visible on landward side however unable to confirm additional crossings. Only 1 crossing was found at this location. (DWR UCIP - O. Magana)

Sump 153 Plan and Profile, existing Pump Plant No. 3 referenced.

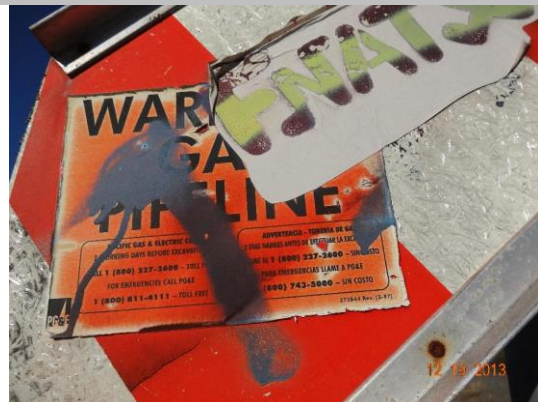
Photo 2 of 3 : UCIP_SP_2019_52679_52768.jpg

Marker with emergency contact information located on waterward slope.

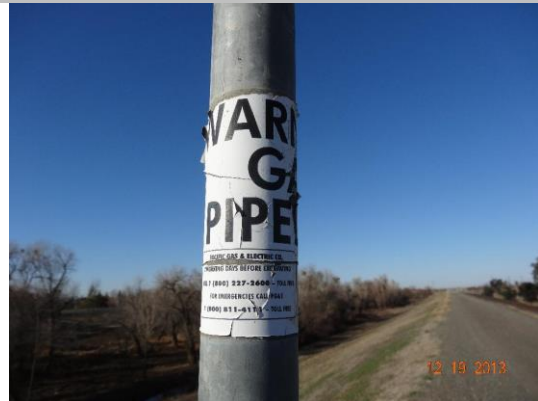
Photo 3 of 3 : UCIP_SP_2019_52679_52767.jpg

FS_ID:52679
DS_ID:24277
EP_NO: 2333
Repair Type: Non-Urgent
Crossing Status: Indicator Found
UCIP Comments: 11/3/2014 Need to contact owner to determine status of crossing. Priority under Part IX has been changed from Urgent to Non-Urgent as a measure to normalize the data. Markers present however unable to confirm pipe size. Recommend LMA to contact owner to determine additional information details--confirm pipe size, alignment, and last inspection completed confirming integrity of crossing. (DWR UCIP - O. Magana)
12/19/2013 Need to contact owner to determine status of crossing. Unable to confirm if indicators visible on levee crown and landward side correspond to this crossing. (DWR UCIP - O. Magana)
FIELD_STRUCT_DESC: *ABANDONED* 12-inch gas line of unknown material through the levee, 3 feet below the crown. Abandoned by grouting in 2002. In case of an emergency related to this pipeline, PG&E has identified the following contacts: PG&E's local pipeline engineer, Mike Aronoff at 916-307-9472 (cell), and Gas Control (north) at 800-442-4743. For non-emergency issues, please contact the local PG&E Gas Pipeline Operations and Maintenance (GPOM) supervisors for the Sacramento region, David Wade at 209-639-1039 (cell), or Ron Hicks at 916-396-9038 (cell). (12-inch line authorized under Permit No. 2333, 1957 - Pacific Gas and Electric Company [PG&E]) [Additional Reference(s): DWR Levee Log, 2002]

Marker located on the waterward side.

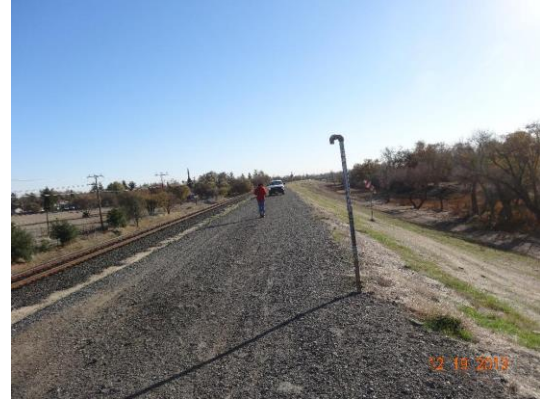
Photo 1 of 3 : UCIP_SP_2019_52682_52778.jpg

Comment Code						
Inspector Comment						
FS_ID:52682 DS_ID:24614 EP_NO: 1450 Repair Type: Non-Urgent Crossing Status: Indicator Found UCIP Comments: Need to contact owner to determine if pipe was left inside levee as part of abandonment process. FIELD_STRUCT_DESC: *ABANDONED* 12-inch steel gas line through the levee, 3 feet below the crown. Concrete cutoff wall around pipe under center of levee. Abandoned by grouting in 2002. In case of an emergency related to this pipeline, PG&E has identified the following contacts: PG&E's local pipeline engineer, Mike Aronoff at 916-307-9472 (cell), and Gas Control (north) at 800-442-4743. For non-emergency issues, please contact the local PG&E Gas Pipeline Operations and Maintenance (GPOM) supervisors for the Sacramento region, David Wade at 209-639-1039 (cell), or Ron Hicks at 916-396-9038 (cell). (12-inch pipe abandoned under Permit No. 17468, 2004 - Pacific Gas and Electric Company [PG&E]; 12-inch line authorized under Permit No. 1450, 1949 - PG&E) [Additional Reference(s): DWR Levee Log, 2002. USACE Sacramento O&M Manual Unit 118, Part No. 2, October 1959, (Station 243+31)] FS Date: 12/19/2013

LM Start	1.03	Rating **	M	Issue No.	155 (cont)
LM End	1.03	Issue Type +	En	Location *

Overview of levee crown at crossings.

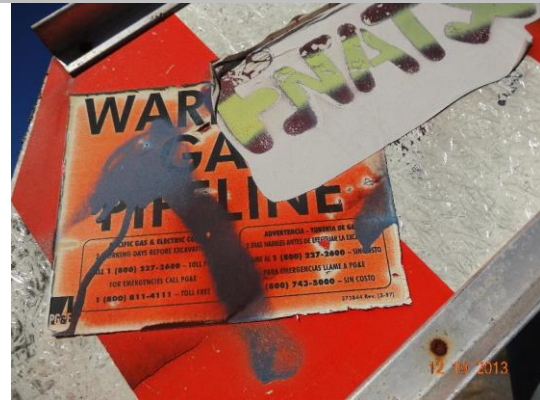
Photo 2 of 3 : UCIP_SP_2019_52682_52780.jpg

Marker with emergency contact information located on waterward slope.

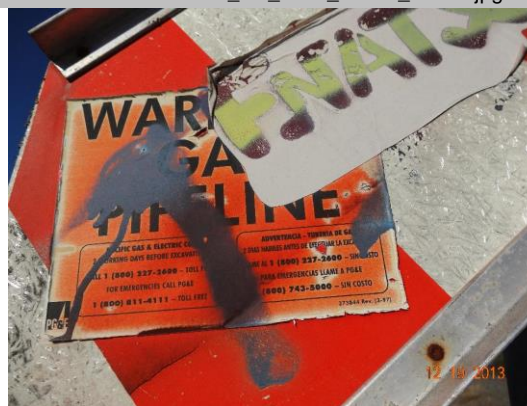
Photo 2 of 3 : UCIP_SP_2019_52684_52774.jpg

UCIP Comments: 08/11/2017 PG&E records for L-119A indicate that there were no observations found on the 07/2017 patrol, no leaks found on the 04/2017 leak survey, and the pipeline is operating correctly according to the 06/2017 CP inspection. ILI in 2016; this integrity assessment identified no issues requiring corrective action. (DWR UCIP - A. McDonald)11/3/2014 Need to contact owner to determine status of crossing. Priority under Part IX has been changed from Urgent to Non-Urgent as a measure to normalize the data. Markers present however unable to confirm pipe size. Recommend LMA to contact owner to determine additional information details--confirm pipe size, alignment, and last inspection completed confirming integrity of crossing. (DWR UCIP - O. Magana)

Marker visible on waterward slope.

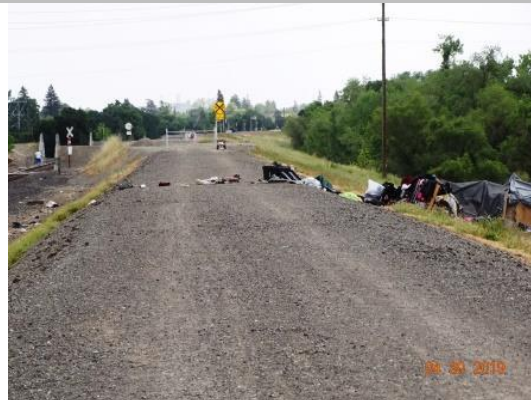
Photo 1 of 1 : SP_2019_NA0001_52_46_20190501_00056.jpg

LM Start	1.50	Rating **	M	Issue No.	46
LM End	1.50	Issue Type +	En	Location *	CR
Category	Earthen Levee			GPS Latitude/Longitude	
				Start	End
Item	Encroachments			38.622452 °	38.622452 °
				-121.468267 °	-121.468267 °
DWR ID	DWR_NA0001_02_s_2019_46				
Comment Code					
DE : Debris					
Inspector Comment					
Remove homeless debris from crown.

View of homeless debris on crown. Spring 2019

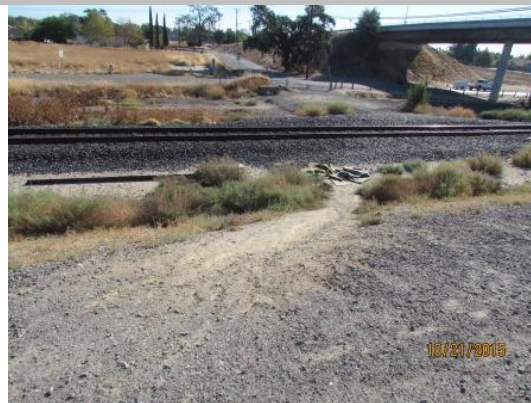
Photo 1 of 1 : SP_2019_NA0001_52_25_20190307_00012.jpg

LM Start	2.05	Rating **	M	Issue No.	25
LM End	2.05	Issue Type +	Ma	Location *	LS
Category	Earthen Levee			GPS Latitude/Longitude	
				Start	End
Item	Slope Stability			38.630425 °	38.630425 °
				-121.469807 °	-121.469807 °
DWR ID	DWR_NA0001_02_f_2015_25				
Comment Code					
S2 : Repair the levee slope damaged by foot traffic and prevent access where possible.					
Inspector Comment

View of the landside levee slope damaged by foot traffic.

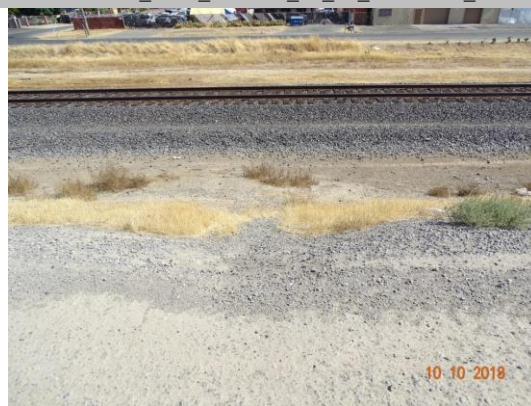
Photo 1 of 1 : SP_2019_NA0001_52_31_20190307_00017.jpg

LM Start	2.22	Rating **	A/W	Issue No.	31
LM End	2.22	Issue Type +	Ma	Location *	LS
Category	Earthen Levee			GPS Latitude/Longitude	
				Start	End
Item	Slope Stability			38.632841 °	38.632841 °
				-121.470258 °	-121.470258 °
DWR ID	DWR_NA0001_02_f_2018_31				
Comment Code					
S1 : Repair slope instability.					
Inspector Comment					
Monitor slope damage.

View of slope damage possibly from foot traffic. Fall 2018

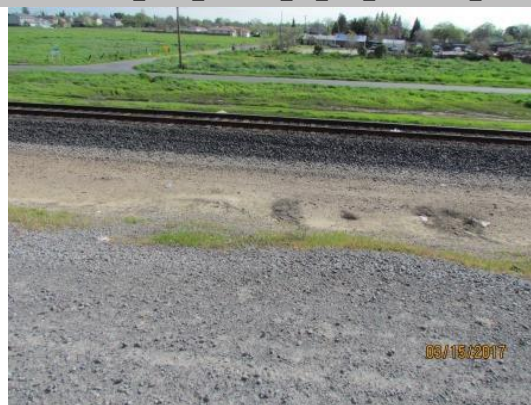
Photo 1 of 2 : SP_2019_NA0001_52_150_20190307_00026.jpg

LM Start	2.33	Rating **	A/W	Issue No.	150
LM End	2.33	Issue Type +	Ob	Location *	LS
Category	Earthen Levee			GPS Latitude/Longitude	
				Start	End
Item	Erosion / Bank Caving			38.634446 °	38.634446 °
				-121.470573 °	-121.470573 °
DWR ID	DWR_NA0001_02_s_2012_150				
Comment Code					
E1 : Note and monitor erosion site.					
Inspector Comment					
Monitor erosion at this location. Also noted in USACE PI.

Spring 2017 - View of the depression, the issue has not gotten any worse since the fall 2011 inspection.

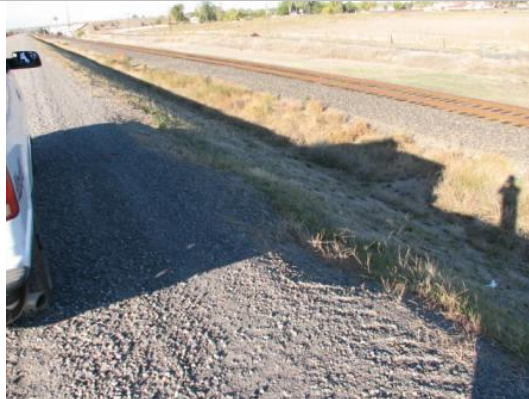
Photo 2 of 2 : SP_2019_NA0001_52_150_20190307_00027.jpg

LM Start	2.33	Rating **	A/W	Issue No.	150 (cont)	
LM End	2.33	Issue Type +	Ob	Location *	LS	
Category	Earthen Levee			GPS Latitude/Longitude		
				Start		End
Item	Erosion / Bank Caving			38.634446 °		38.634446 °
				-121.470573 °		-121.470573 °
DWR ID	DWR_NA0001_02_s_2012_150					
Comment Code						
E1 : Note and monitor erosion site.						
Inspector Comment						
Monitor erosion at this location. Also noted in USACE PI.

11/16/2011 Depressions present on levee slope.

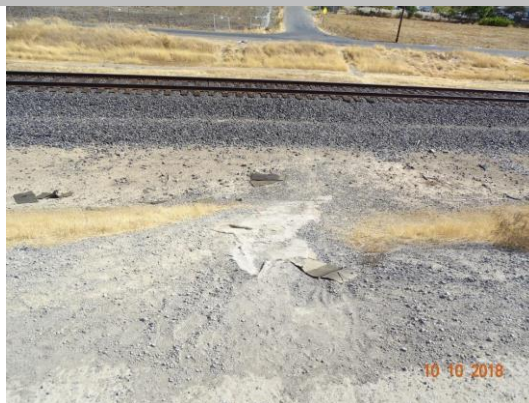
Photo 1 of 1 : SP_2019_NA0001_52_29_20190307_00015.jpg

LM Start	2.36	Rating **	M	Issue No.	29
LM End	2.36	Issue Type +	Ma	Location *	LS
Category	Earthen Levee			GPS Latitude/Longitude	
				Start	End
Item	Slope Stability			38.634885 °	38.634885 °
				-121.470643 °	-121.470643 °
DWR ID	DWR_NA0001_02_f_2018_29				
Comment Code					
S2 : Repair the levee slope damaged by foot traffic and prevent access where possible.					
Inspector Comment					
Repair footpath on levee slope.

View of footpath on levee slope. Fall 2018

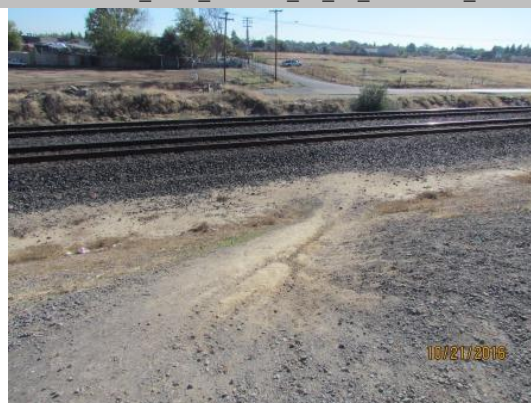
Photo 1 of 1 : SP_2019_NA0001_52_27_20190307_00014.jpg

LM Start	2.59	Rating **	M	Issue No.	27
LM End	2.59	Issue Type +	Ma	Location *	LS
Category	Earthen Levee			GPS Latitude/Longitude	
				Start	End
Item	Slope Stability			38.638109 °	38.638109 °
				-121.471254 °	-121.471254 °
DWR ID	DWR_NA0001_02_f_2016_27				
Comment Code					
S2 : Repair the levee slope damaged by foot traffic and prevent access where possible.					
Inspector Comment

View of the foot path on the landside levee slope. Fall 2016

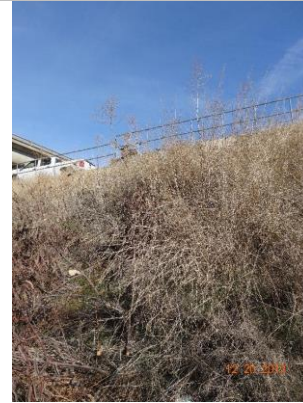
Photo 3 of 3 : UCIP_SP_2019_49862_52894.jpg

Comment Code						
Inspector Comment						
FS_ID:49862 DS_ID:24608 EP_NO: 9596 Repair Type: Non-Urgent Crossing Status: Indicator Found UCIP Comments: Dense vegetation on waterward side limits inspector's inspection. Recommend removing vegetation. FIELD_STRUCT_DESC: [Sump No. 157] 1 of 3: 54-inch steel drainage pipe through the levee, 3 feet below the crown. Steel cutoff wall around pipe under center of levee. Siphon breaker in protective housing located on the waterside (WS) shoulder. Concrete headwall and flap gate located on the WS end. Trench on WS. Pumping plant located on the landside (LS). On March 28, 1995, the Sacramento City Council adopted Resolution No. 95-123 authorizing the execution of Agreement No. 95-065 regarding the transfer of drainage facilities that include Pump Station 7 as described by ARFCD and described by the City of Sacramento as Sump 157. (three 54-inch pipes installed in the siphon breaker structure but only one pipe installed through levee under Permit No. 9596, 9596-A, and 1975 - American River Flood Control District; second pipe installed through levee under Permit No. 9596-B, 1980 - American River Flood Control District; name change completed under Permit 9596-1 (includes work authorized under Permit No. 9596, 9596-A, and 9596-B), 2016 - City of Sacramento) [Additional Reference(s): DWR Levee Log, 2002] FS Date: 12/20/2013

Dense vegetation located on waterward slope.

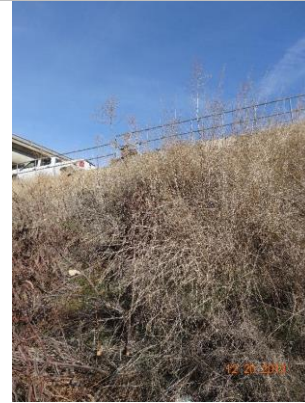
Photo 3 of 3 : UCIP_SP_2019_49863_52906.jpg

Comment Code						
Inspector Comment						
FS_ID:49863 DS_ID:24609 EP_NO: 9596 Repair Type: Non-Urgent Crossing Status: Indicator Found UCIP Comments: Dense vegetation on waterward side limits inspector's inspection--recommend removing vegetation to clear waterward slope. FIELD_STRUCT_DESC: [Sump No. 157] 2 of 3: 54-inch steel drainage pipe through the levee, 3 feet below the crown. Steel cutoff wall around pipe under center of levee. Siphon breaker in protective housing located on the waterside (WS) shoulder. Concrete headwall and flap gate located on the WS end. Trench on WS. Pumping plant located on the landside (LS). On March 28, 1995, the Sacramento City Council adopted Resolution No. 95-123 authorizing the execution of Agreement No. 95-065 regarding the transfer of drainage facilities that include Pump Station 7 as described by ARFCD and described by the City of Sacramento as Sump 157. (three 54-inch pipes installed in the siphon breaker structure but only one pipe installed through levee under Permit No. 9596, 9596-A, and 1975 - American River Flood Control District; second pipe installed through levee under Permit No. 9596-B, 1980 - American River Flood Control District; name change completed under Permit 9596-1 (includes work authorized under Permit No. 9596, 9596-A, and 9596-B), 2016 - City of Sacramento) [Additional Reference(s): DWR Levee Log, 2002] FS Date: 12/20/2013

Dense vegetation located on waterward slope.

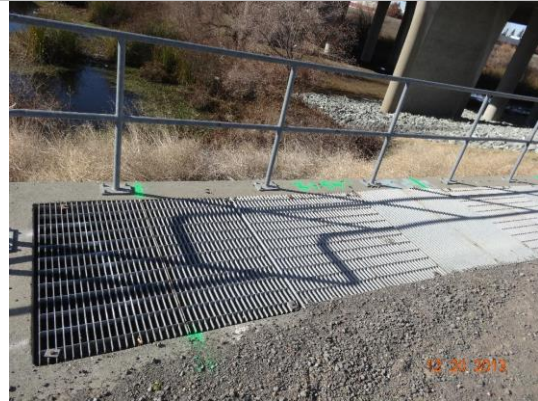
Photo 2 of 3 : UCIP_SP_2019_53492_52910.jpg

FS_ID:53492
 DS_ID:24610
 EP_NO: 9596-1
 Repair Type: Non-Urgent
 Crossing Status: Indicator Found
 UCIP Comments: 07/18/2018 Pumping plant and discharge pipes appear to be the same as last time. Up and over pipe: no flooding risk. Need records from the owner. Crossing downgraded to "Non-Urgent" until we receive records from the owner, indicating that this crossing is in good condition and does not need repair. (DWR UCIP - A. McDonald)09/19/2016 LMA obtained photos of the pipes while the City of Sacramento was conducting work on the air relief valves, third pipe is a partial install unable to determine the total length of the pipe through the levee. (DWR UCIP - omagana)08/11/2016 Based on permit review for 9596, 9596-A, and 9596-B it appears that the third pipe was never installed through the levee and only the WS pipe section in the siphon breaker was installed. The section through the levee is to be installed as a future enlargement of the Pumping Plant. Need to coordinate with owner to determine how pipe is sealed through the levee. Gate missing on WS. (DWR UCIP - omagana)12/20/2013 Signs of pipe removal are visible on waterward and landward side--gate missing on WS and pump missing on LS. Need to contact owner to determine status of crossing. (DWR UCIP - omagana)

Concrete box contains 3-54 inch crossings.

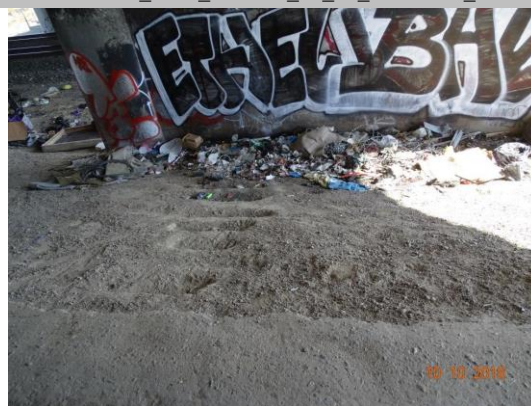
Photo 1 of 1 : SP_2019_NA0001_52_22_20190307_00009.jpg

LM Start	2.81	Rating **	M	Issue No.	22
LM End	2.81	Issue Type +	Ma	Location *	LS
Category	Earthen Levee			GPS Latitude/Longitude	
				Start	End
Item	Slope Stability			38.641309 °	38.641309 °
				-121.471798 °	-121.471798 °
DWR ID	DWR_NA0001_02_f_2018_22				
Comment Code					
S2 : Repair the levee slope damaged by foot traffic and prevent access where possible.					
Inspector Comment					
Steps cut into levee slope.

View of foot path steps cut into levee. Fall 2018

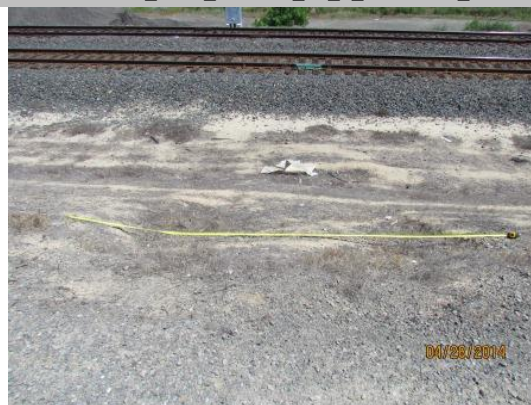
Photo 1 of 1 : SP_2019_NA0001_52_6_20190307_00002.jpg

LM Start	2.92	Rating **	A/W	Issue No.	6
LM End	2.92	Issue Type +	Ma	Location *	LS
Category	Earthen Levee			GPS Latitude/Longitude	
				Start	End
Item	Slope Stability			38.642950 °	38.642950 °
				-121.472166 °	-121.472166 °
DWR ID	DWR_NA0001_02_f_2018_6				
Comment Code					
S1 : Repair slope instability.					
Inspector Comment					
Monitor this location.

View of landside slope instability. Spring 2014

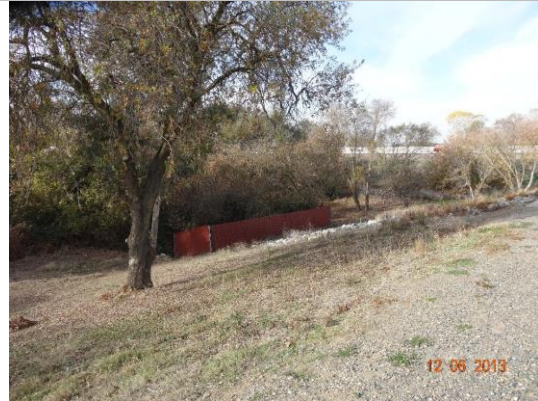
Photo 1 of 3 : UCIP_SP_2019_50047_53005.jpg

LM Start	1.53	Rating **	M	Issue No.	25 (cont)
LM End	1.53	Issue Type +	En	Location *

View of WS.

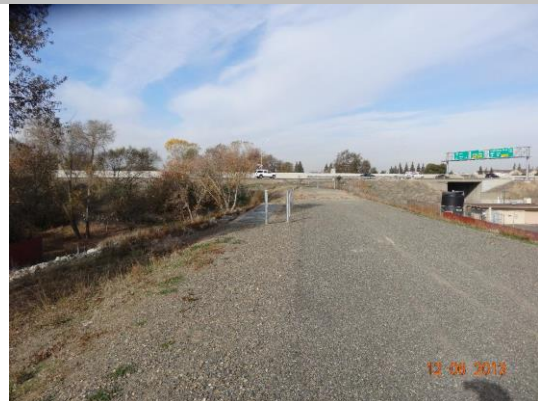
Photo 2 of 3 : UCIP_SP_2019_50047_53004.jpg

View of levee crown--concrete vault located on WS shoulder.

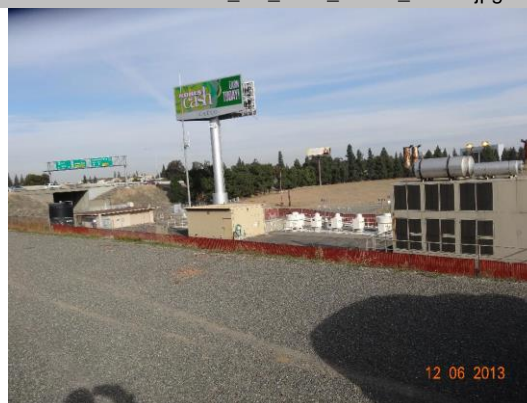
Photo 3 of 3 : UCIP_SP_2019_50047_53003.jpg

Comment Code						
Inspector Comment						
FS_ID:50047 DS_ID:24292 EP_NO: 5776 Repair Type: Non-Urgent Crossing Status: Found UCIP Comments: 8/11/2016 Issue has been addressed--no hole is present at site. Hole could have been associated with burrow activity. Need to contact owner to obtain internal integrity inspection to confirm pipe is in good condition. Crossing has been changed from Urgent to Non-Urgent due to limited evidence to support leak in pipe. (DWR UCIP - omagana)12/3/2013 Hole present next to concrete vault on levee crown (waterward side). Hole could be sink hole or burrow activity unable to determine. Need to contact owner to determine status of crossing and to investigate hole. (DWR UCIP - omagana) FIELD_STRUCT_DESC: [Drainage Plant No. 2] 5 of 6: 18-inch steel drainage pipe through the levee at an unknown depth below the crown. Metal cutoff wall around pipe under landside (LS) shoulder. Siphon breakers in concrete box located on the waterside (WS) shoulder. Pumping plant at LS toe. Access ramp to pumping plant located on LS. Concrete discharge box located on the WS. Flap gate located on the WS end. Outfall structure located on the WS. (Permit No. 5776, 1972 - American River Flood Control District; name change completed under Permit No. 5776-1, 2016 - City of Sacramento). [Additional Reference(s): DWR Levee Log, 2002]. FS Date: 8/11/2016

View of LS.

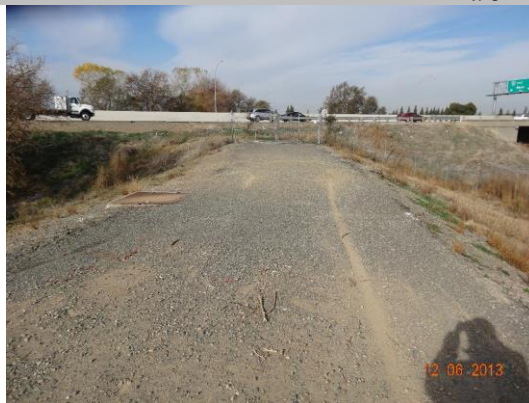
Photo 1 of 3 : UCIP_SP_2019_31224_57130.jpg

LM Start	1.54	Rating **	M	Issue No.	26 (cont)
LM End	1.54	Issue Type +	En	Location *

View of levee crown and concrete box located on waterward shoulder.

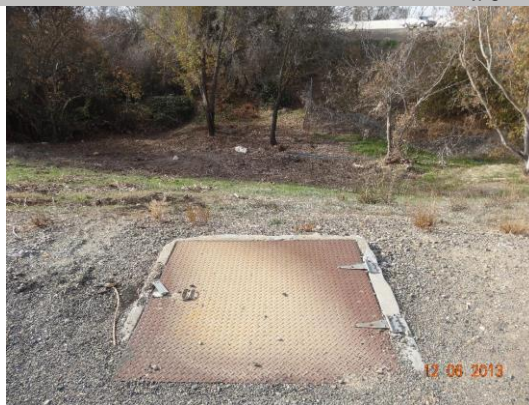
Photo 2 of 3 : UCIP_SP_2019_31224_57129.jpg

Concrete box located on waterward shoulder.

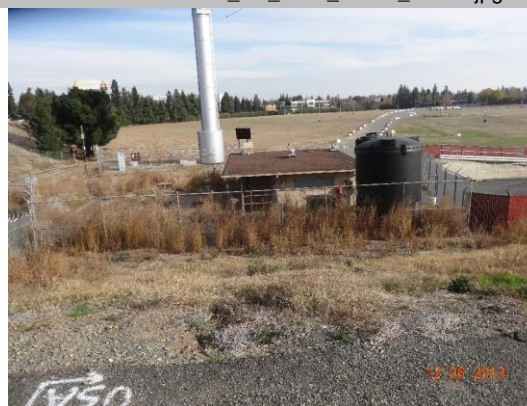
Photo 2 of 3 : UCIP_SP_2019_31225_57134.jpg

LM Start	1.54	Rating **	M	Issue No.	27 (cont)	
LM End	1.54	Issue Type +	En	Location *		
Category	Supplemental			GPS Latitude/Longitude		
				Start	End	
Item	DWR UCIP Field Study			38.593290 °	38.593290 °	
				-121.443980 °	-121.443980 °	
DWR ID	24645					
Comment Code						
Inspector Comment						
FS_ID:31225 DS_ID:24645 EP_NO: 2805 Repair Type: Non-Urgent Crossing Status: Indicator Found UCIP Comments: Unable to confirm what crossings are going through levee. Will need to coordinate with owner to determine active crossings. FIELD_STRUCT_DESC: [Arden Treatment Plant] 4 of 4: 34-inch concrete encased sewer pipe through the levee, 6.2 feet below the crown. Concrete cutoff wall around pipe under center of levee. Siphon breaker in housing at waterside (WS) shoulder. Treatment plant on landside (LS). [Additional Reference(s): DWR Levee Log, 2002] FS Date: 12/3/2013

View of landward side.

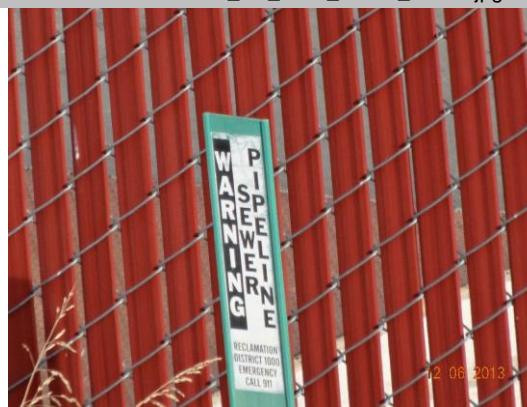
Photo 3 of 3 : UCIP_SP_2019_31225_57132.jpg

Sewer marker visible on landward toe.

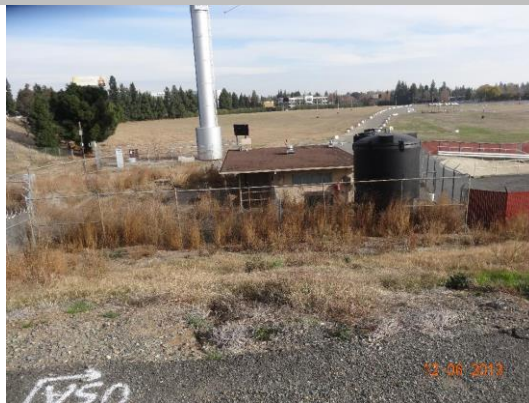
Photo 2 of 3 : UCIP_SP_2019_31227_57138.jpg

Comment Code						
Inspector Comment						
FS_ID:31227						
DS_ID:24293						
EP_NO: 2805						
Repair Type: Non-Urgent						
Crossing Status: Indicator Found						
UCIP Comments: Will need to coordinate with the owner to determine the status of the crossings.						
FIELD_STRUCT_DESC: [Sacramento County Sanitation District No. 2 Pump Station] 18-inch concrete sewer main through the levee, 6 feet below the crown, 2 feet below slopes, and 4 feet along channel bottom. Concrete cutoff wall around the pipe under the center of the levee. 2-inch air release valve located on the waterside (WS) shoulder of the north levee. Treatment plant on the landside (LS). Crossing continues under the channel and through the opposite levee. (18-inch pipe authorized under Permit No. 2805, 1958 - Sacramento County Sanitation District No. 2).						
FS Date: 12/3/2013

View of landward side.

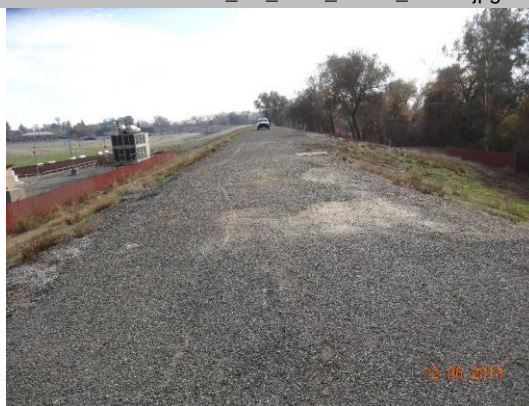
Photo 3 of 3 : UCIP_SP_2019_31227_57143.jpg

Comment Code						
Inspector Comment						
FS_ID:31227						
DS_ID:24293						
EP_NO: 2805						
Repair Type: Non-Urgent						
Crossing Status: Indicator Found						
UCIP Comments: Will need to coordinate with the owner to determine the status of the crossings.						
FIELD_STRUCT_DESC: [Sacramento County Sanitation District No. 2 Pump Station] 18-inch concrete sewer main through the levee, 6 feet below the crown, 2 feet below slopes, and 4 feet along channel bottom. Concrete cutoff wall around the pipe under the center of the levee. 2-inch air release valve located on the waterside (WS) shoulder of the north levee. Treatment plant on the landside (LS). Crossing continues under the channel and through the opposite levee. (18-inch pipe authorized under Permit No. 2805, 1958 - Sacramento County Sanitation District No. 2).						
FS Date: 12/3/2013

View of levee crown looking upstream.

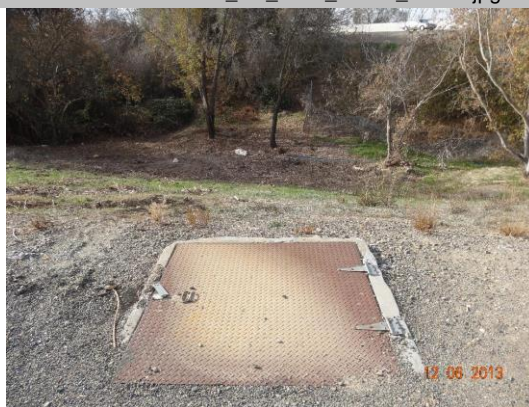
Photo 2 of 3 : UCIP_SP_2019_31223_57123.jpg

FS_ID:31223
DS_ID:24643
EP_NO: 2805
Repair Type: Non-Urgent
Crossing Status: Indicator Found
UCIP Comments: Unable to confirm what crossings are going through levee. Will need to coordinate iwth owner to determine active crossings.
FIELD_STRUCT_DESC: [Co Sanitation District No. 2 Pump Station]: 24-inch reinforced concrete sewer main through the levee, 2.5 feet below the crown. Concrete cutoff wall around pipe under center of levee. Siphon breaker in housing at waterside (WS) shoulder. Treatment plant on landside (LS). Line connects to an existing 18-inch sewer line and 8-inch line installed under permit no. 6216. The line also connects to an existing 24-inch line located on the LS. The 24-inch line on LS parallels the levee for approximately 54 feet and ends at the pump station. (8-inch and 24-inch sewage force main fro Arden treatment plant to Elvas Freeway authorized under Permit No. 6216, 1969-Arden Sanitation District County of Sacramento, Utilities Division)

Concrete box located on waterward shoulder.

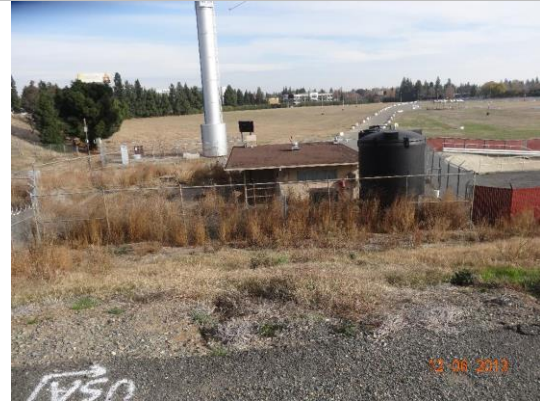
Photo 3 of 3 : UCIP_SP_2019_31223_57122.jpg

Comment Code					
Inspector Comment					
FS_ID:31223 DS_ID:24643 EP_NO: 2805 Repair Type: Non-Urgent Crossing Status: Indicator Found UCIP Comments: Unable to confirm what crossings are going through levee. Will need to coordinate iwth owner to determine active crossings. FIELD_STRUCT_DESC: [Co Sanitation District No. 2 Pump Station]: 24-inch reinforced concrete sewer main through the levee, 2.5 feet below the crown. Concrete cutoff wall around pipe under center of levee. Siphon breaker in housing at waterside (WS) shoulder. Treatment plant on landside (LS). Line connects to an existing 18-inch sewer line and 8-inch line installed under permit no. 6216. The line also connects to an existing 24-inch line located on the LS. The 24-inch line on LS parallels the levee for approximately 54 feet and ends at the pump station. (8-inch and 24-inch sewage force main fro Arden treatment plant to Elvas Freeway authorized under Permit No. 6216, 1969-Arden Sanitation District County of Sacramento, Utilities Division) FS Date: 12/3/2013

View of landward side.

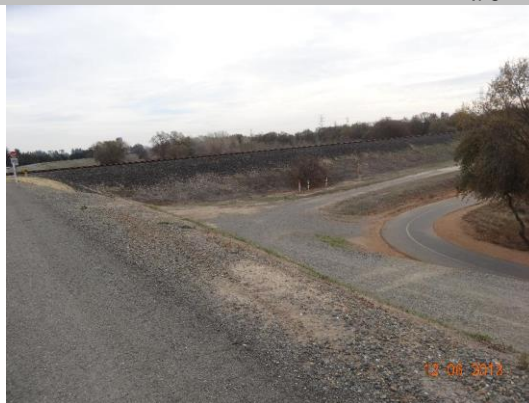
Photo 1 of 3 : UCIP_SP_2019_31230_57146.jpg

LM Start	1.91	Rating **	M	Issue No.	30	
LM End	1.91	Issue Type +	En	Location *		
Category	Supplemental			GPS Latitude/Longitude		
				Start	End	
Item	DWR UCIP Field Study			38.596096 °	38.596096 °	
				-121.449815 °	-121.449815 °	
DWR ID	24801					
Comment Code						
Inspector Comment						
FS_ID:31230						
DS_ID:24801						
EP_NO: N/A						
Repair Type: Non-Urgent						
Crossing Status: Found						
UCIP Comments: No permit found--need to contact owner to determine status of crossing.						
FIELD_STRUCT_DESC: Gas line through levee at unknown depth.						
Markers visible on waterside (WS) and landside (LS). Kinder Morgan contacts' information is 916-363-1666.						
FS Date: 12/6/2013

View of waterward side.

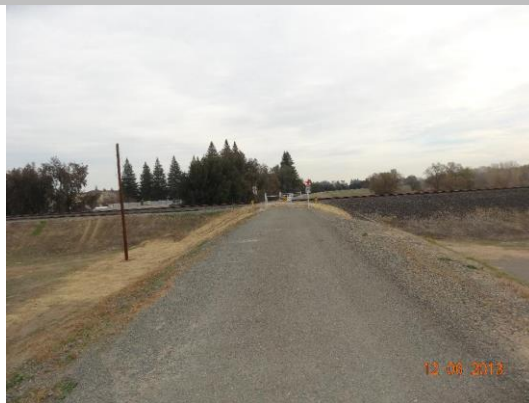
Photo 2 of 3 : UCIP_SP_2019_31230_57145.jpg

Overview of levee crown at crossing.

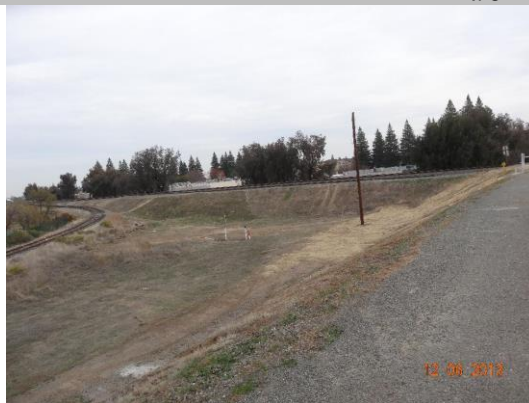
Photo 3 of 3 : UCIP_SP_2019_31230_57144.jpg

LM Start	1.91	Rating **	M	Issue No.	30 (cont)	
LM End	1.91	Issue Type +	En	Location *		
Category	Supplemental			GPS Latitude/Longitude		
				Start	End	
Item	DWR UCIP Field Study			38.596096 °	38.596096 °	
				-121.449815 °	-121.449815 °	
DWR ID	24801					
Comment Code						
Inspector Comment						
FS_ID:31230						
DS_ID:24801						
EP_NO: N/A						
Repair Type: Non-Urgent						
Crossing Status: Found						
UCIP Comments: No permit found--need to contact owner to determine status of crossing.						
FIELD_STRUCT_DESC: Gas line through levee at unknown depth.						
Markers visible on waterside (WS) and landside (LS). Kinder Morgan contacts' information is 916-363-1666.						
FS Date: 12/6/2013

View of landward side.

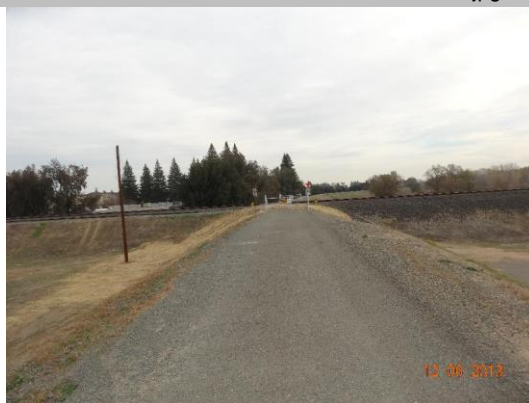
Photo 1 of 3 : UCIP_SP_2019_29826_55135.jpg

LM Start	1.91	Rating **	M	Issue No.	31
LM End	1.91	Issue Type +	En	Location *	
Category	Supplemental			GPS Latitude/Longitude	
				Start	End
Item	DWR UCIP Field Study			38.596108 °	38.596108 °
				-121.449887 °	-121.449887 °
DWR ID	24294				
Comment Code					
Inspector Comment					
FS_ID:29826 DS_ID:24294 EP_NO: N/A Repair Type: Non-Urgent Crossing Status: Indicator Found UCIP Comments: Unable to confirm the diameter size or which owner is responsible for crossing. Owner could be Quest Communication or MCI--Need to contact owner to confirm crossing and obtain encroachment permit for work. FIELD_STRUCT_DESC: Communications conduit through the levee at unknown depth. [Additional Reference(s): DWR Levee Log, 2002] FS Date: 12/6/2013

Overview of levee crown looking upstram at crossing.
